Final Report:

Assessing the Potential of Reduction Pruning in Mitigating the Risk of Branch Failure

Report of findings and recommendations

BioCompliance Consulting, Inc.
10/30/2012

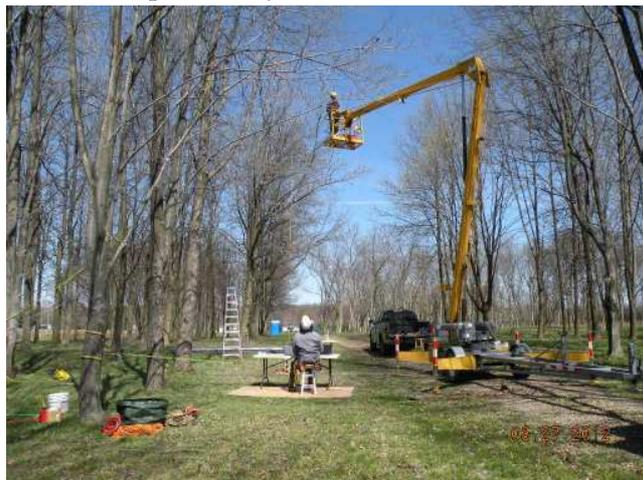
Figure 1. Trees on Davey’s Shalersville, OH test site

The test location was the Davey Tree Company’s research arboretum in Shalersville, Portage County, Ohio. This is the same site as was used in the previously referenced branch failure investigation. It is also the site that hosted ISA Tree Biomechanics Week in August 2010.

Several species of trees commonly found as street trees were established at this location in the 1960’s for the purpose of developing and testing new arboriculture practices. The crowns of individual trees in each of the planting blocks had closed to create a continuous canopy. The management objective for the research blocks was to create full crowns similar to those of street and landscape trees. Thinning operations to open up the stands of test trees are anticipated. This presented the

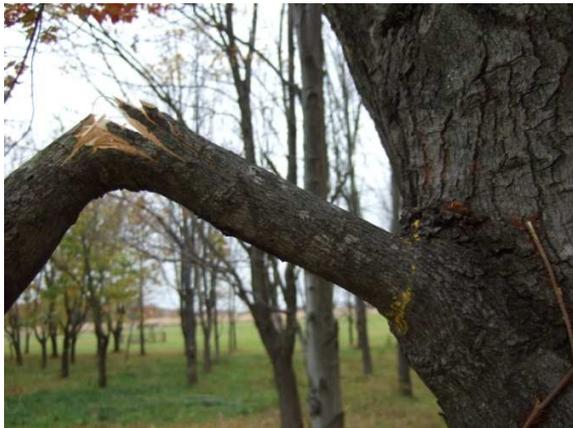
Figure 2. The CFZ is close, but not at, the branch union with main stem or parent branch.

Previous work⁶ by the researches on static loading of branches to the point of failure identified a Critical Fracture Zone (CFZ) typically located within 5-10% of total branch length to the main stem. Other researchers^{7, 8} have also reported similar anecdotal observations suggest that the

failure point is often located at a distance of two to four times the branch or stem base diameter, and is related to the transition from a relatively flexible branch or stem into a relatively stiff branch or stem base. The compressive and tensile stresses relative to the branch's ability to resist are critical in this CFZ. In effect, the branch is a lever arm, and bending moment-induced stress can be reduced by shortening and lightening the outer end of the lever arm.

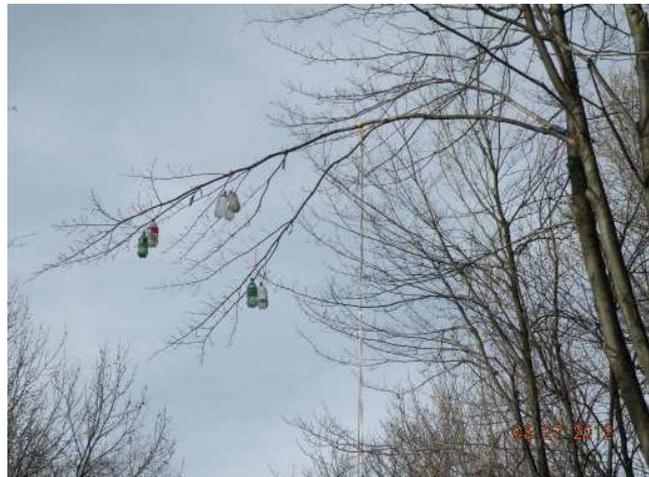
Figure 3. A branch subjected to load line tension and simulated weight of ice added to segments to be removed, prior to pruning.

The second phase of the test involved loading and reduction pruning of the branch. The branch was preloaded to 75% of its estimated maximum. The theoretical load added by one-half inch of ice to each pruning segment was calculated as previously described. Water bottles containing water with the ice-equivalent weights for each segment were attached at each segment's CG.

The fully loaded branch subject to forces being applied both by the load line and the weight of ice (water equivalent) was then progressively reduced using the two pruning doses that have been previously described. The second dose reduced the branch to the full extent possible while still remaining

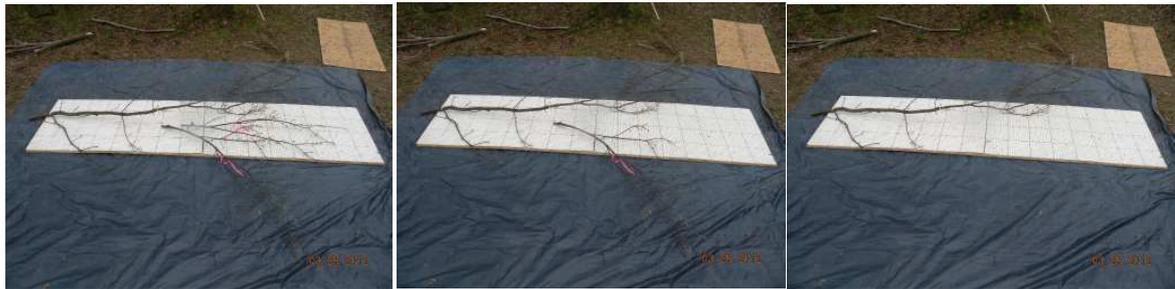
Figure 4. An example of a series of progressive branch reductions. Full branch on left, first order reduction in center, and full reduction on right.

Once removed from the tree, the weight of the residual branch and the weights of the segments that had been pruned away with each reduction dose were recorded. The branch was then laid out on a grid, placing the residual branch and the segments removed in the approximate orientation that they occupied in the tree prior to pruning. A sketch¹¹ of each branch was created and a series of photographs¹² were taken to illustrate the extent of each reduction dose.
